Te Otamanui Fatal Flaw Assessment

Prepared for Hamilton City Council

Prepared by CH2M Beca Ltd

3 May 2017

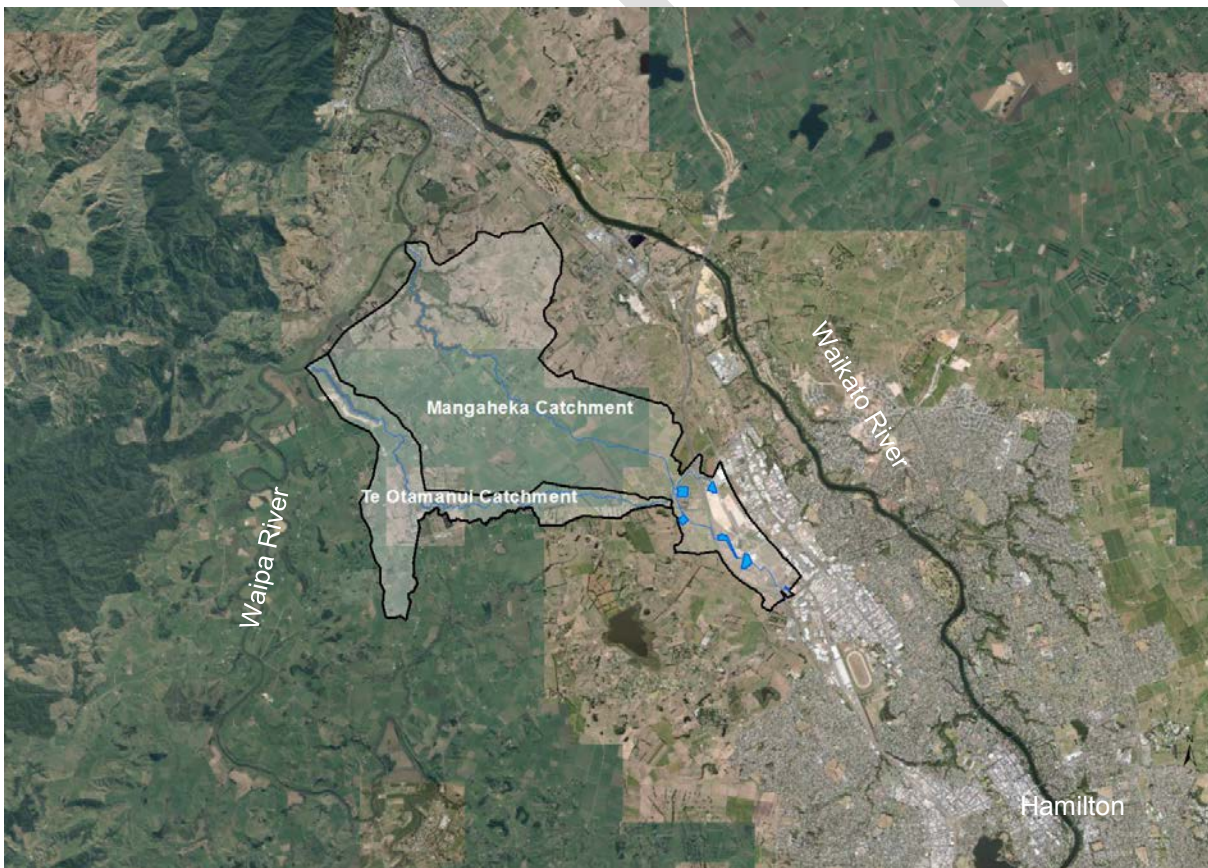
Figure 1 Te Otamanui Catchment Location

Figure 1 shows the location of the Te Otamanui Stream catchment, the Mangaheka Stream catchment and Hamilton City.

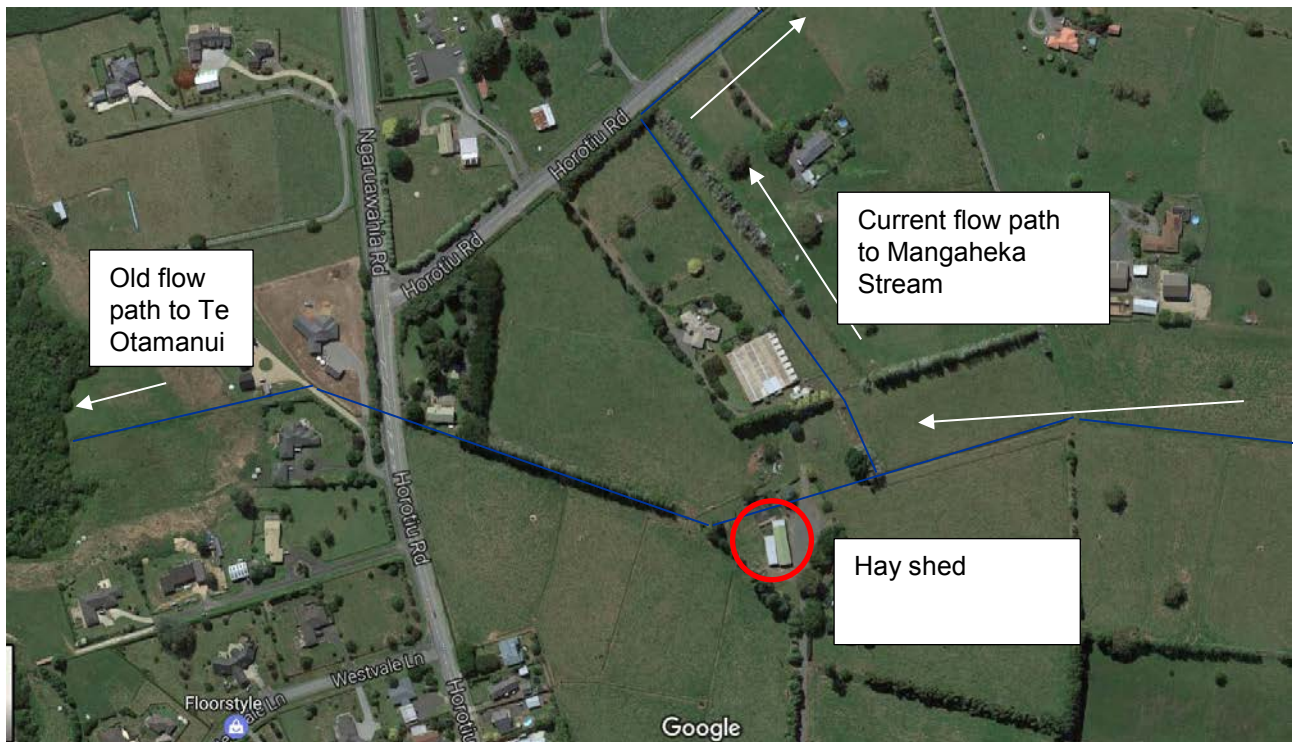
Figure 3: 714 Te Kowhai Road property

During conversations with Graham McBride, a previous Waipa Zone Liaison Committee Chairman, Graham could not recall any specific flooding events but he did mention that there is no connectivity from the Mangaheka Catchment to the Te Otamanui Catchment at Koura Drive. He also noted that in the past there was a diversion at Ken Commons’ property at 714 Te Kowhai Road in Te Kowhai. It was proposed build a hay barn over a drain at 714 Te Kowhai Road but at the time there was no record of the drain and therefore HCC granted the consent. Having granted consent, they then had to allow a drain diversion to occur. Instead of going underneath Horotiu Road to the Te Otamanui catchment, the drain was apparently diverted into the Mangaheka Catchment. Mr McBride also suggested that Te Otamanui is an old path of the Waipa River. It is possible that this diversion has impacted on the water levels in the Te Otamanui catchment and lagoon.

Figure 3 shows the approximate location of the diversion and hay shed. Note that the location and presence of a diversion has not has been verified by either Graham McBride or Beca.

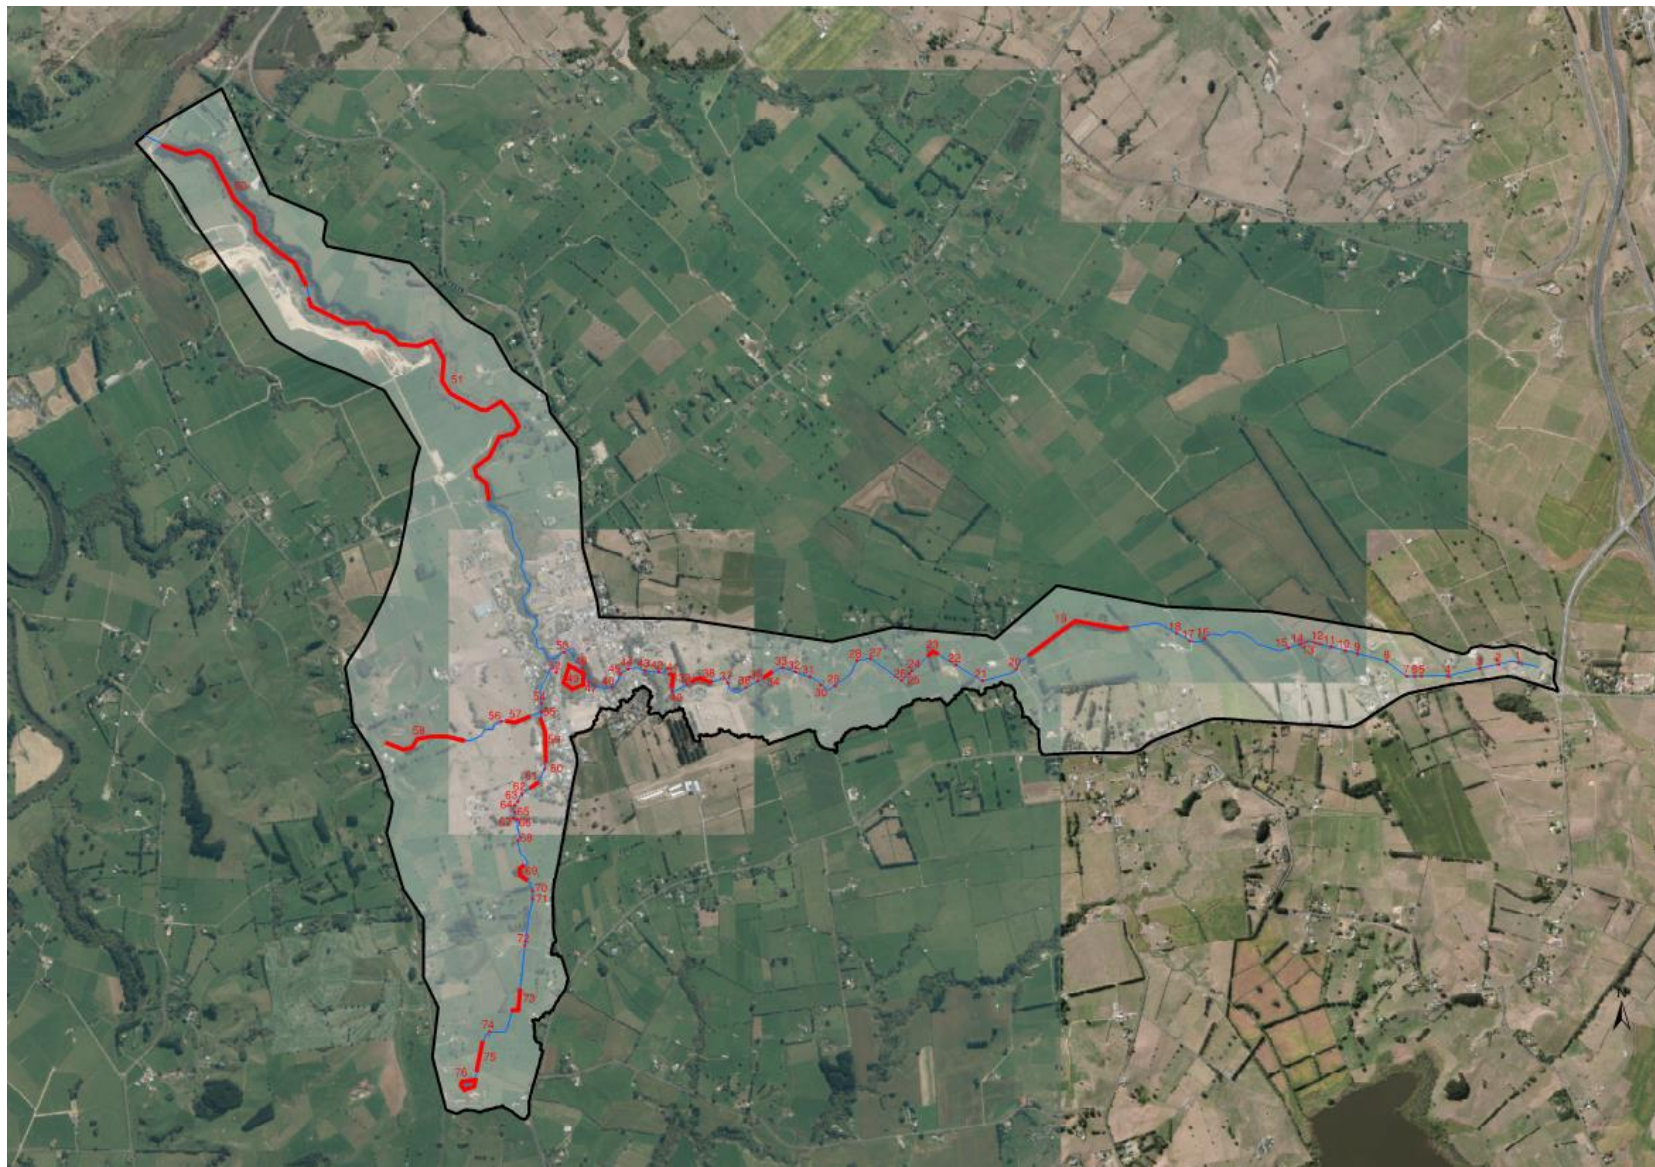
Appendix A shows a list of the obstructions which were clear in aerial photography as well as a map showing the location of each obstruction.

12	E	Trees - unclear if stream blocked from aerial				
13	F	Debris (e.g. logs) over stream	logs			
14	B	Grass covered bridge /culvert				
15	A	Gravel/seal driveway - bridge/culvert				
16	E	Trees - unclear if stream blocked from aerial				
17	A	Gravel/seal driveway - bridge/culvert				
18	A	Gravel/seal driveway - bridge/culvert				
19	E	Trees - unclear if stream blocked from aerial				
20	G	Major road culvert/bridge	Te Kowhai Rd			
21	A	Gravel/seal driveway - bridge/culvert				
22	B	Grass covered bridge /culvert				
23	E	Trees - unclear if stream blocked from aerial				
24	E	Trees - unclear if stream blocked from aerial				
25	B	Grass covered bridge /culvert				
26	E	Trees - unclear if stream blocked from aerial				
27	H	Fence across stream	unclear			
28	I	Building within 5m of stream	shed			
29	A	Gravel/seal driveway - bridge/culvert				
30	F	Debris (e.g. logs) over stream	unclear			
31	H	Fence across stream	unclear

32	A	Gravel/seal driveway - bridge/culvert	32 + 33 one culvert combined			
33	A	Gravel/seal driveway - bridge/culvert	32 + 33 one culvert combined			
34	J	Stream opens out into pond				
35	C	Other bridge/culvert	unclear			
36	B	Grass covered bridge /culvert	small grass bridge			
37	B	Grass covered bridge /culvert				
38	E	Trees - unclear if stream blocked from aerial				
39	A	Gravel/seal driveway - bridge/culvert				
40	J	Stream opens out into pond				
41	K	Wetland area with vegetation	also trees - unclear if stream blocked			
42	C	Other bridge/culvert	stream emerges from culvert			
43	F	Debris (e.g. logs) over stream	logs?			
44	C	Other bridge/culvert	small bridge			
45	E	Trees - unclear if stream blocked from aerial				
46	C	Other bridge/culvert	small bridge			
47	E	Trees - unclear if stream blocked from aerial	one bridge, rest of area unclear

There are a number of resource consents granted (or in process) by the Waikato Regional Council for activities in the catchment which may have an impact on the Te Otamanui stream and its hydrology especially if additional water is discharged. The locations of these are shown in Appendix A.

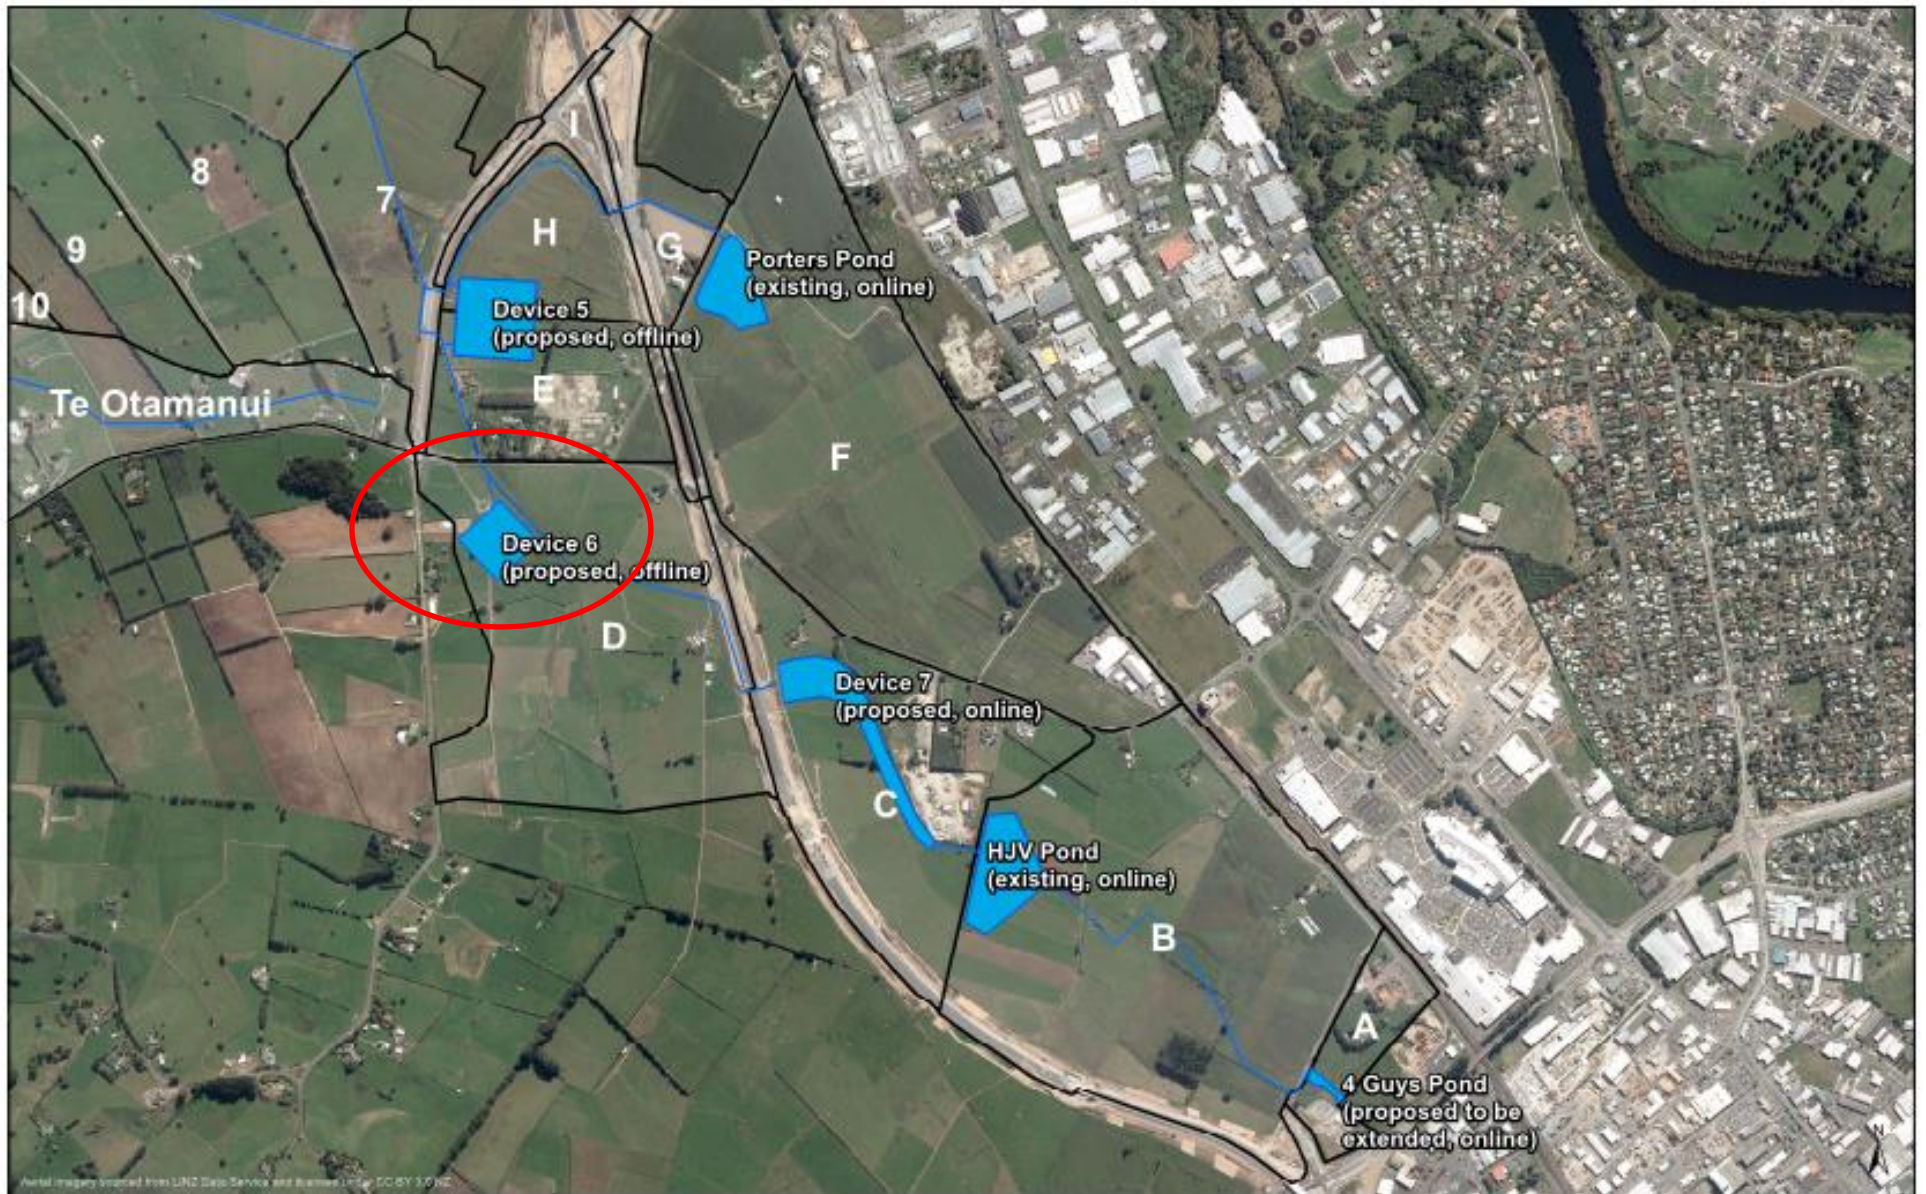
Device 6 Location

MANGAHEKA MAXIMUM PROBABLE DEVELOPMENT CATCHMENT BOUNDARIES CLOSE UP		FOR INFORMATION ONLY	
CH2M BECA		1:11,000 @ A3		1 OF 1

- Divert flood flows from Mangaheka directly from Device 6; a proposed attenuation pond for mitigating runoff from development of the Upper Mangaheka catchment. This device is located at a higher level than the upper reaches of the Te Otamanui Stream. Therefore, a diversion from Device 6 could occur under gravity. Such a diversion could provide positive effects on the Te Otamanui stream but could also reduce the size of Device 6. Device 6 is shown in Appendix C.
