Mangaheka Watercourse Assessment and Programme of Works

Prepared for Hamilton City Council by Morphum Environmental Ltd
22/05/2017

Client Name: Hamilton City Council
Project Name: Mangaheka
Project Number: P01282
Document: Mangaheka Watercourse Assessment and Programme of Works

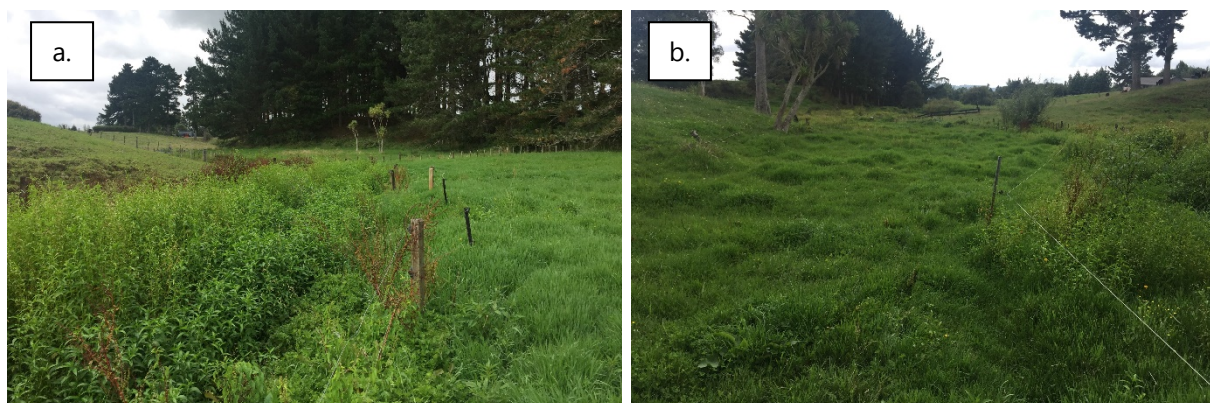
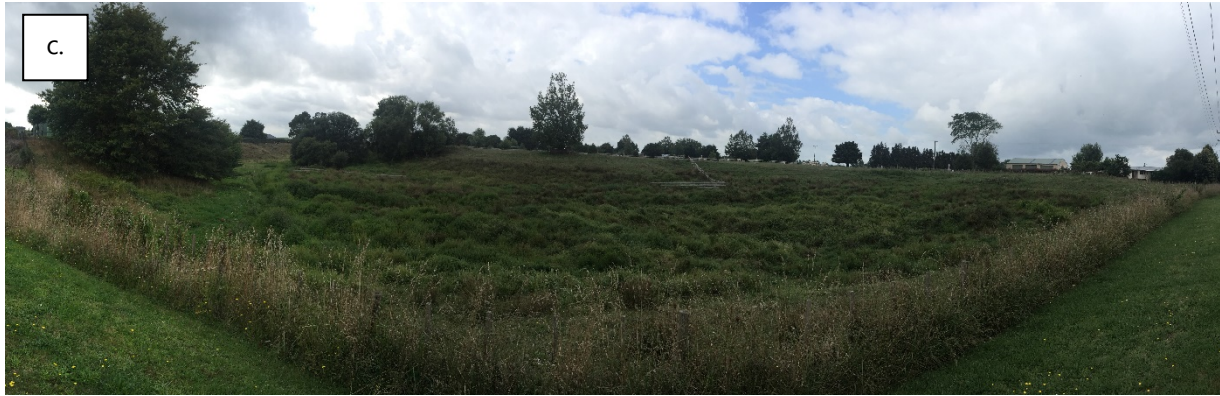
Reach 1, 2 and 3 are characterised as low energy, highly depositional wetland environments. The reaches are characterised as wide cushiony floodplains that have approximately 0.5 m of water below the surface. The reaches were assessed to have low susceptibility to erosion given the proximity to upstream development and relatively low grade. The most likely process resulting in erosion is from the disturbance of soil and bank structure caused by stock during grazing of these wetland areas. This is due to the lack of exclusion fences in most of these wetland type areas.

Figure 2: Figure 2a and 2b illustrate the fencing off of the channel along reach 2 however, the surrounding low lying pasture land that is not encompassed within this fence has been identified as a floating wetland type as described above. Figure 2c shows the wetland in panorama.

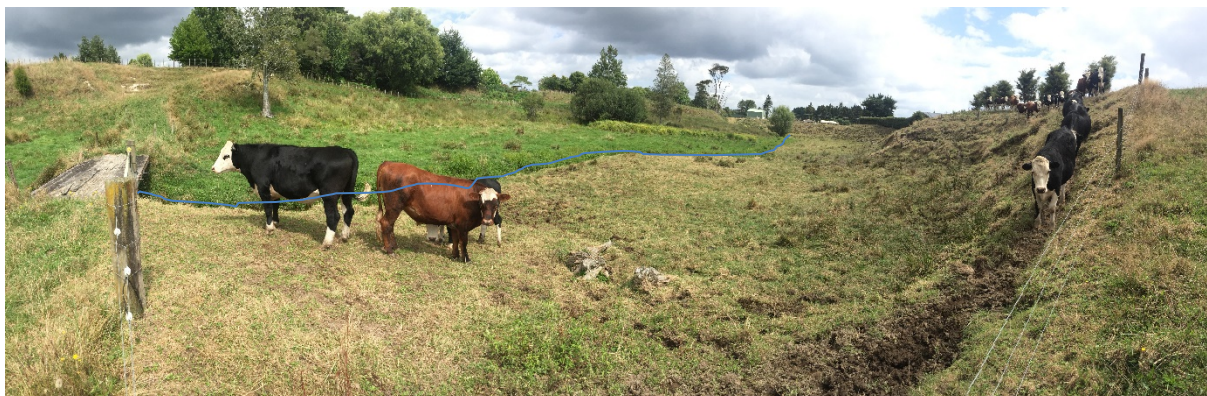
Reach 4 and 5 are both considered as low energy, transport reaches due to the low grade of the incised channel. The low bank height and complete vegetation cover on the flood plain minimise the risk of erosion during inundation from high flows. The susceptibility of these reaches to erosion is therefore considered low as there is little evidence of erosion scarring under current conditions. The lack of fencing along these reaches is a concern as stock are evidently grazing right up to the bank, again increasing the likelihood that bank structure may be compromised and increase localised erosion along these reaches.

Figure 3: Illustration of the grazing pressure along the unfenced reach 5. The far bank (TLB) is not grazed, while the near bank (TRB) has been grazed. Grazing pressure was observed right up to the channel edge.

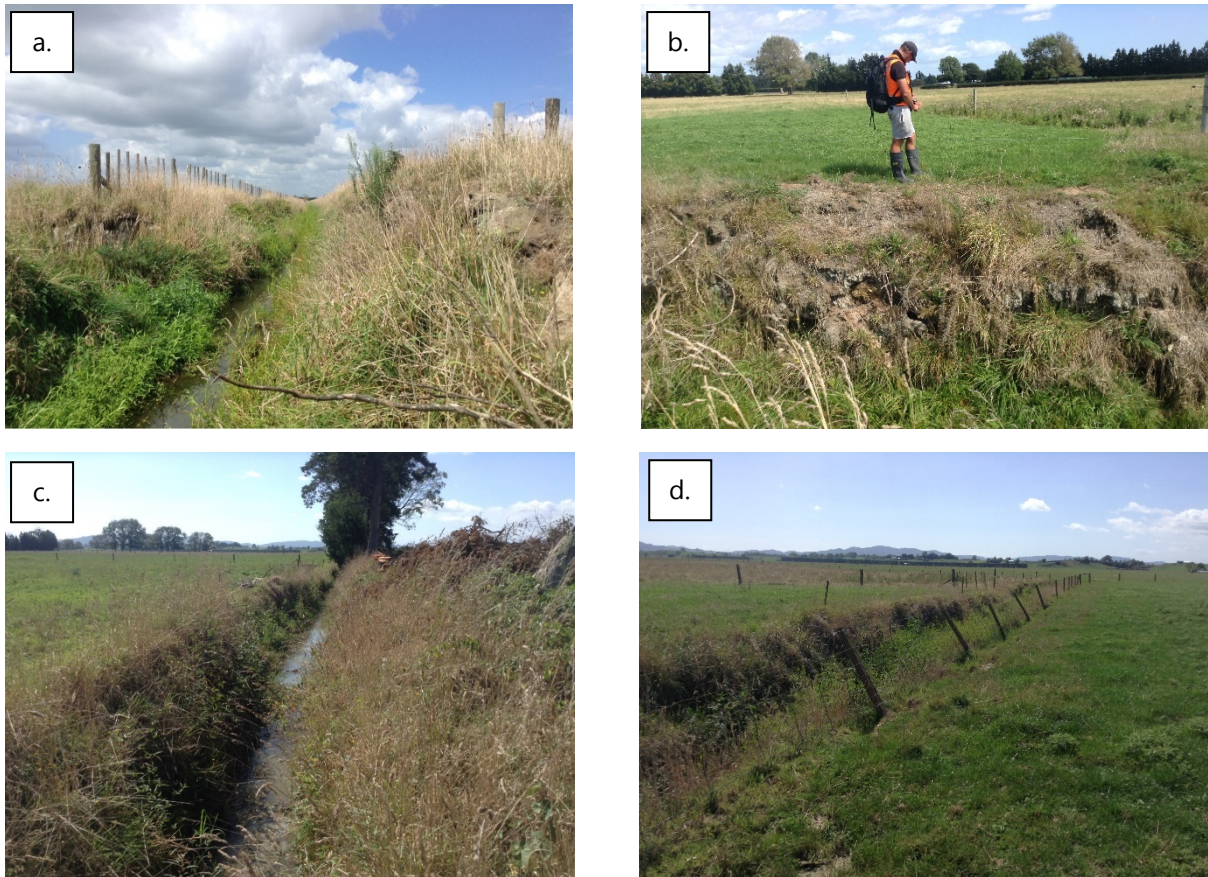
Reach 9 and 10, although highly incised, have been classified as having low to moderate erosion susceptibility due to a stable bank structure and a decrease in channel grade in comparison to reach 7. The drain erosion assessment carried out by Coffey Geotechnics in 2012 identifies these reaches as one of the worst affected areas of the Mangaheka Stream, which aligns with the findings of this report. Slumping of the upper bank is evident in some locations, although the primary cause of this instability appears to be the alignment of the fence in relation to the bank edge in conjunction with very steep near vertical channel banks. Steep banks may have been exacerbated by spraying or where the steepness in the bank has resulted in conditions where grass has not been able to establish in the summer months. The instabilities of the upper bank are extensive along both reaches and may require

a high level of remediation in the form of channel reshaping due to the proximity of the reach to the upstream development.

Figure 5: Figure 5a and 5c indicate the typical channel form along reaches 9 and 10 respectively. Figure 5b and 5d illustrate upper bank instabilities along reaches 9 and 10 caused by steep bank angles and poor fence alignment.
