Location 1

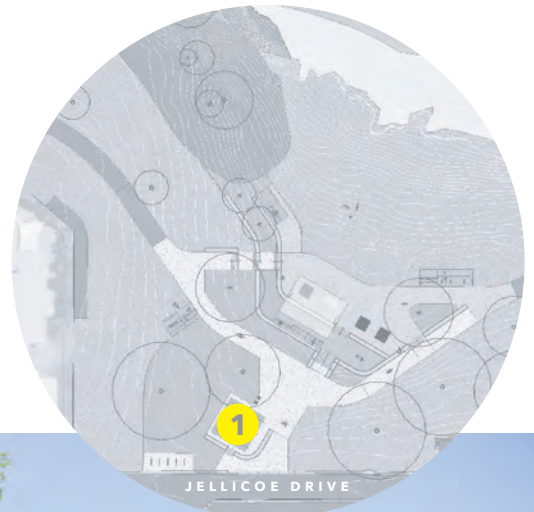
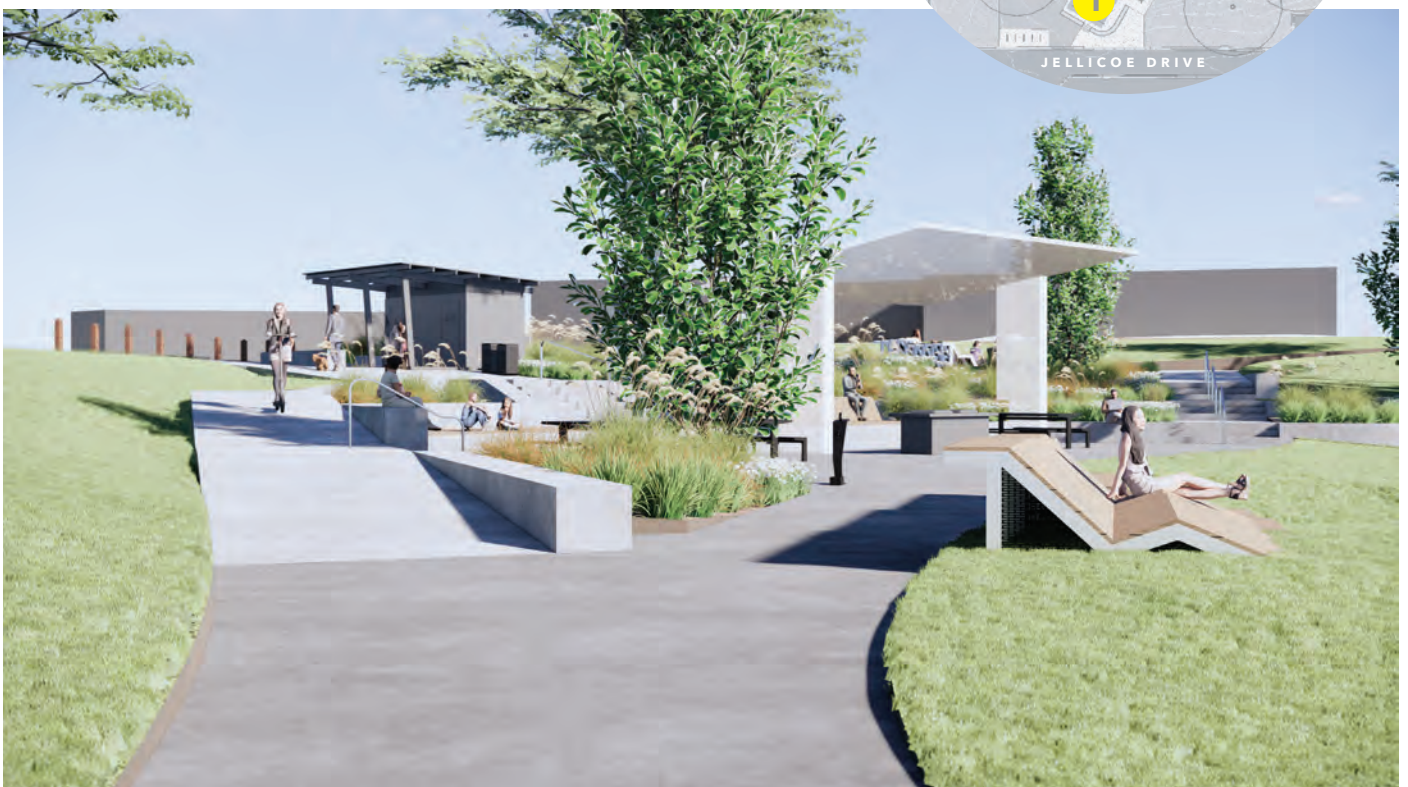
Proposed toilet unit located in a publicly accessible location with safe movement and connections. Layout and orientation is clear and logical. Centrally located to the bus shelter, upper terraces, and barbeque area.

Accessible access to toilet unit from the bus shelter, upper terraces, and barbeque area.

Good sightlines and guardianship from Hayes Common, Jellicoe Drive, the bus shelter, neighbouring residential properties, and users of the Hamilton City River Ride & Walk.

Economical connection to existing services including sewer, stormwater, mains water supply, power, gas, and telecommunication services.

50+ metres to Hayes Paddock Playground.

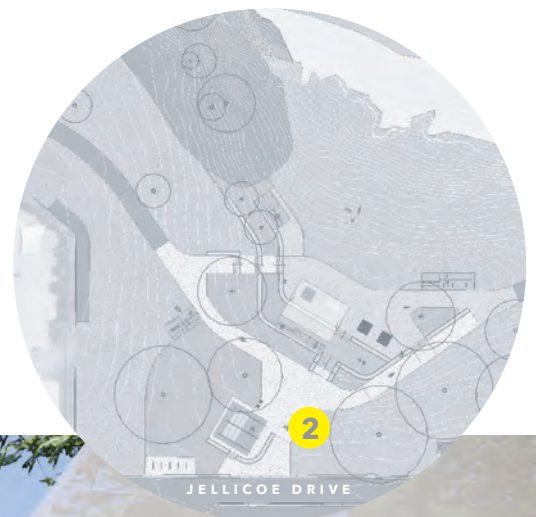
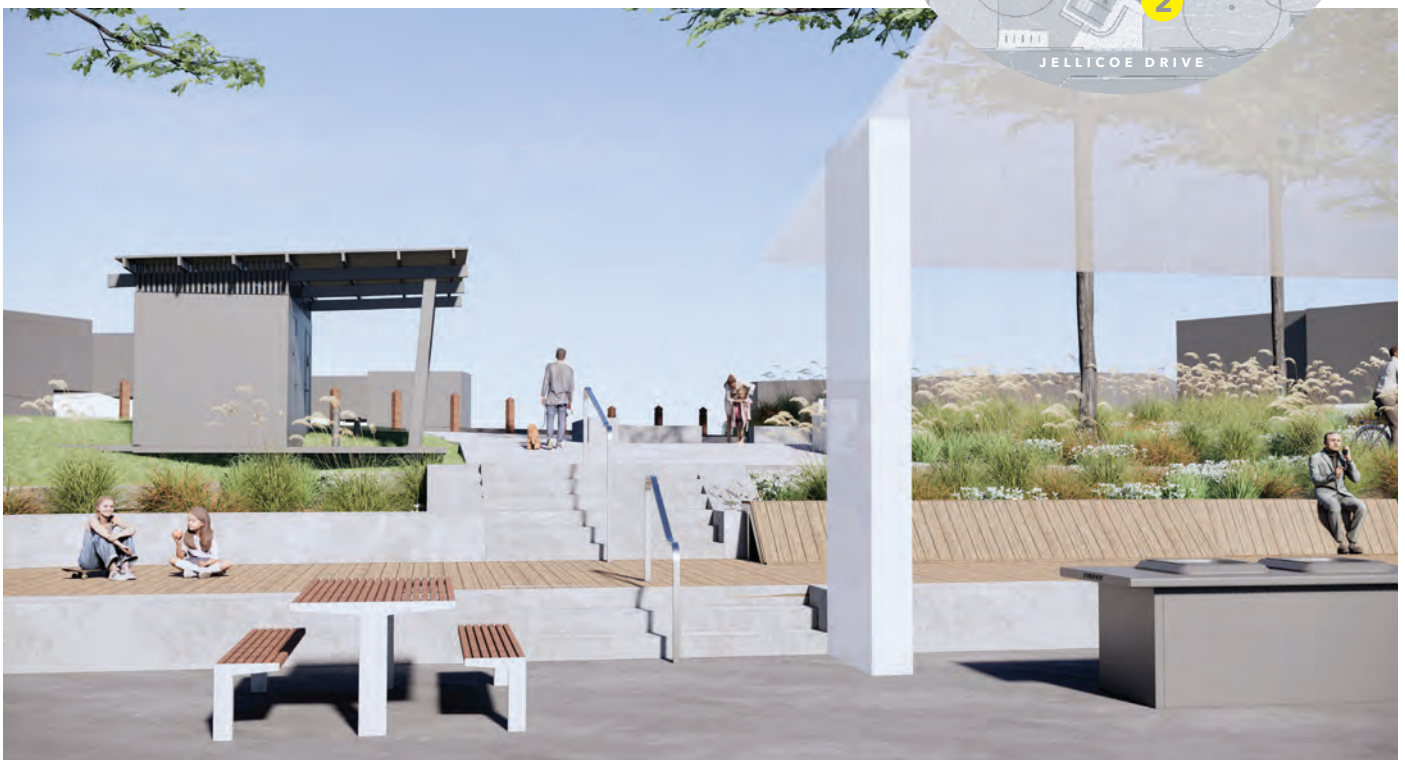
Location 2

Proposed toilet unit located in a publicly accessible location with safe movement and connections. Layout and orientation is clear and logical. Centrally located to the bus shelter, upper terraces, and barbeque area.

Accessible access to toilet unit from the bus shelter, upper terraces, and barbeque area.

Good sightlines and guardianship from Hayes Common, Jellicoe Drive, neighbouring residential properties, and users of the Hamilton City River Ride & Walk.

50+ metres to Hayes Paddock Playground.

Limited sightlines and guardianship from the bus shelter.

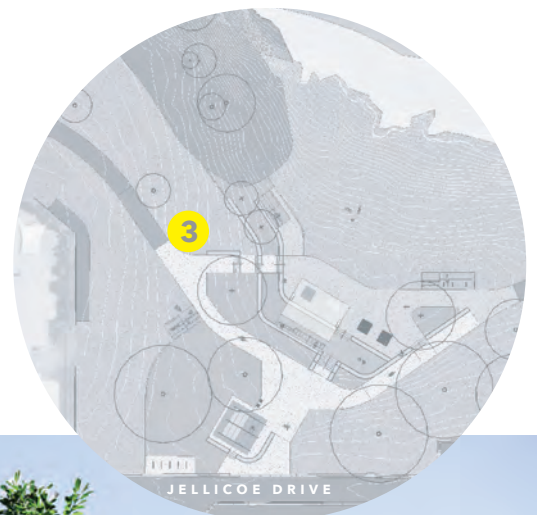
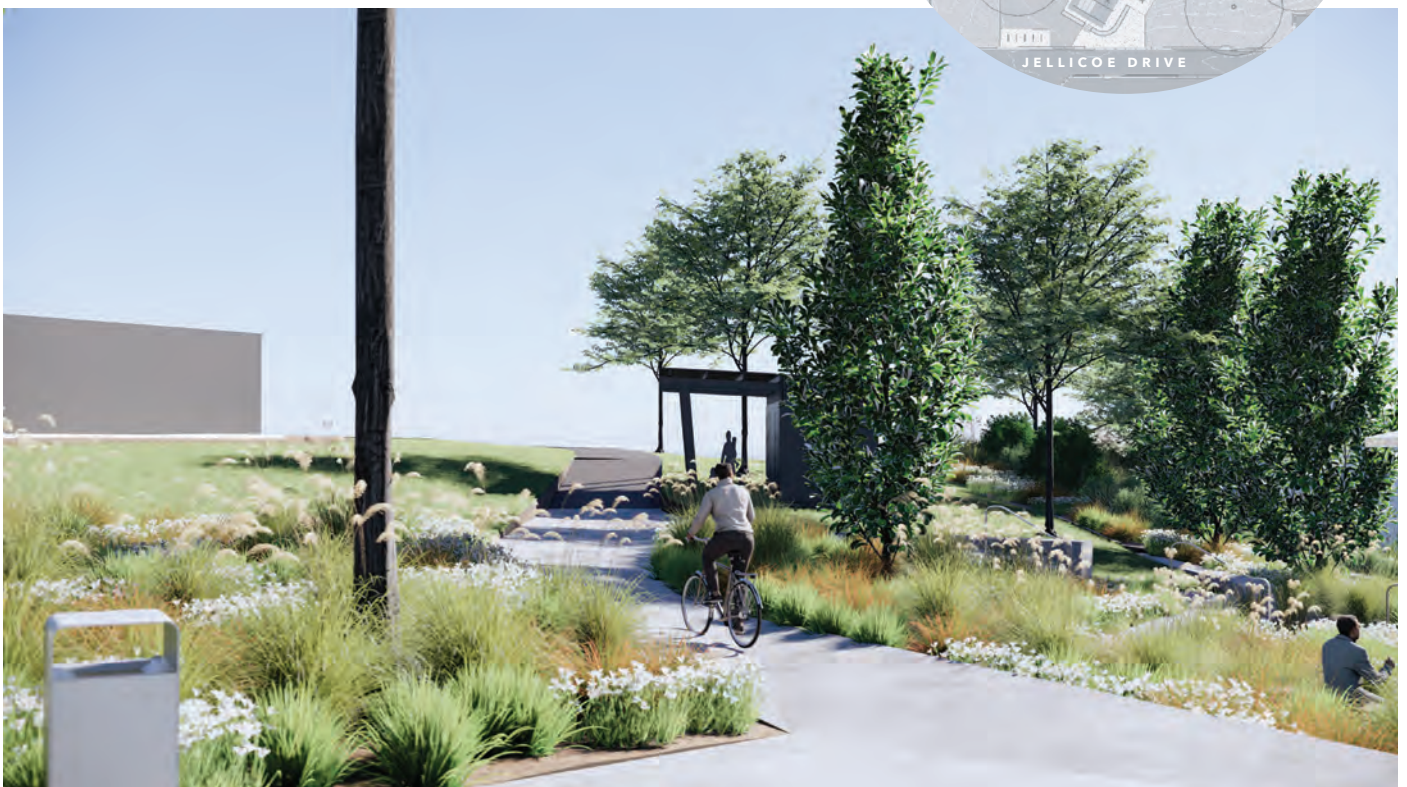
Location 3

Proposed toilet unit located in a publicly accessible location. Centrally located to the upper terraces and barbeque area, and Hayes Paddock Playground.

Good sightlines and guardianship from the users of the Hamilton City River Ride & Walk. Some sightlines from the upper terraces and barbeque area, and Hayes Paddock Playground.

Limited sightlines and guardianship from Hayes Common, Jellicoe Drive, the bus shelter, and neighbouring residential properties.

Some cost to connect to existing services including sewer, stormwater, mains water supply, power, gas, and telecommunication services.
